Conservation Preservation Treatment Report

Fredericksburg, Virginia

**St. Georges Episcopal Church
905 Princess Ann Street
Fredericksburg, Virginia 22401**

January 2021

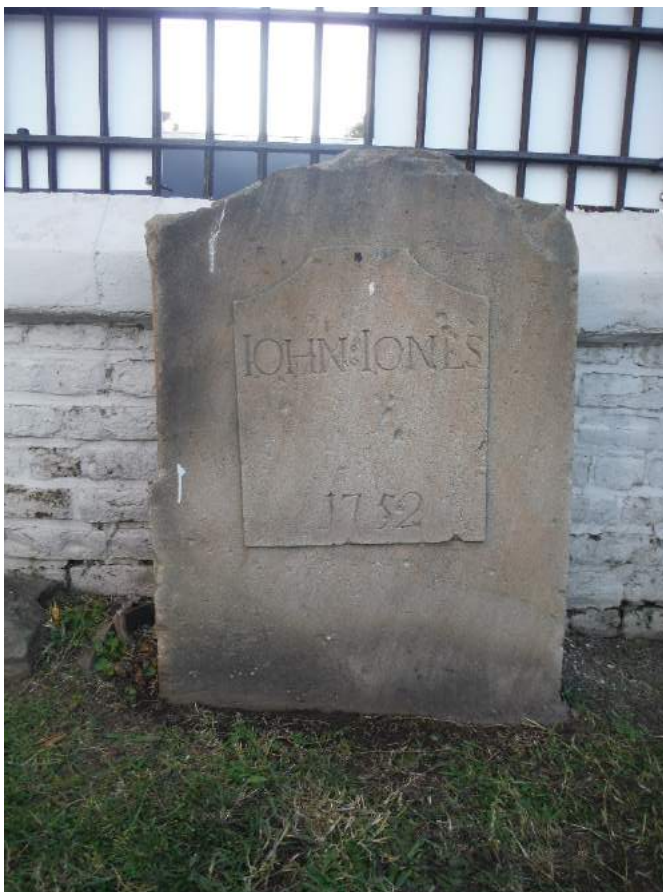
Gravestone # 1

Condition: Gravestone was found to be standing firmly and solidly upright with moderate loss due to spalling across the top, and down the left side facing the stones and one fourth the way down along the right side facing the stone.

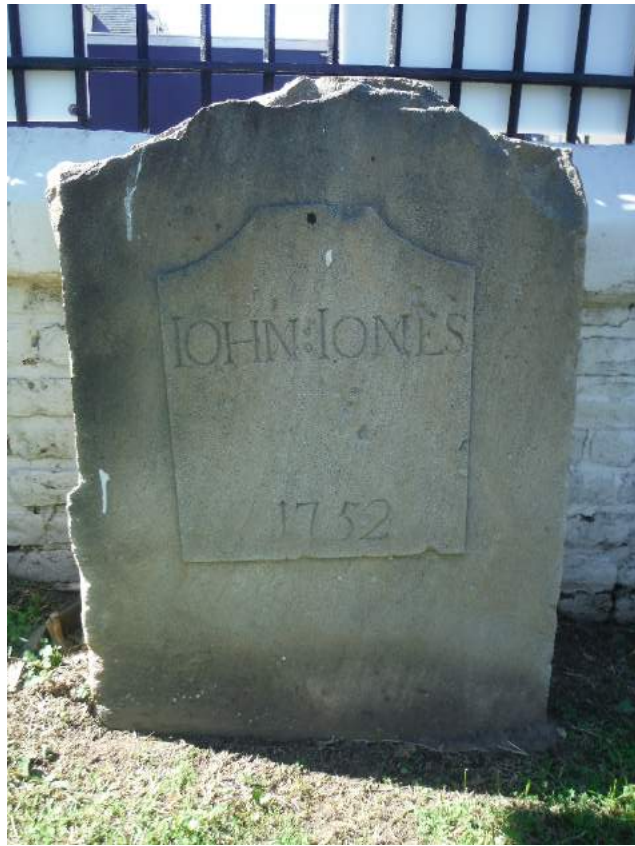
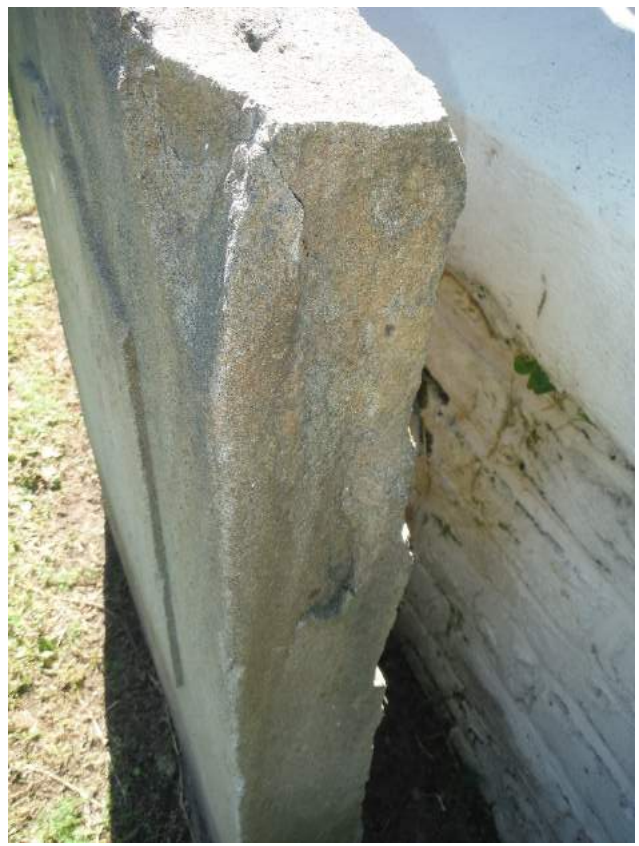
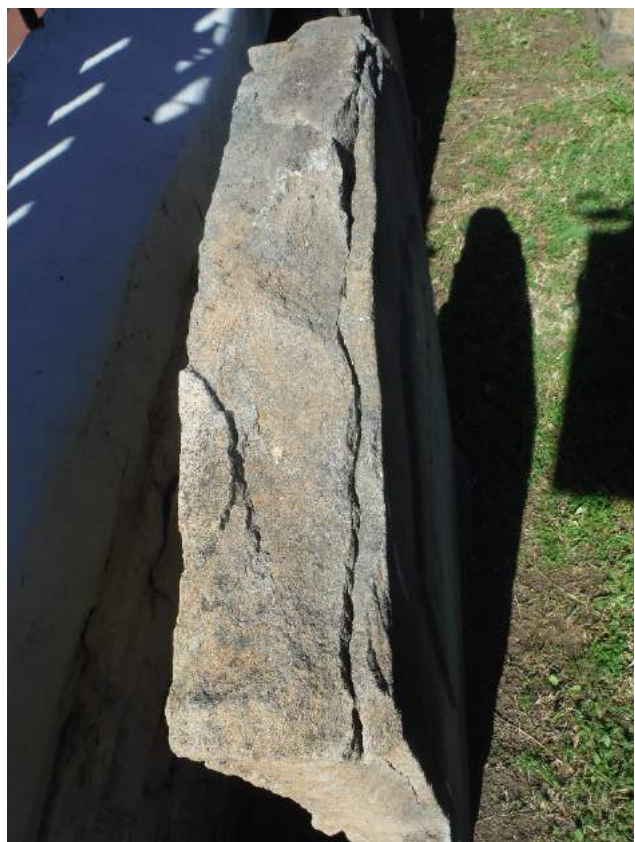
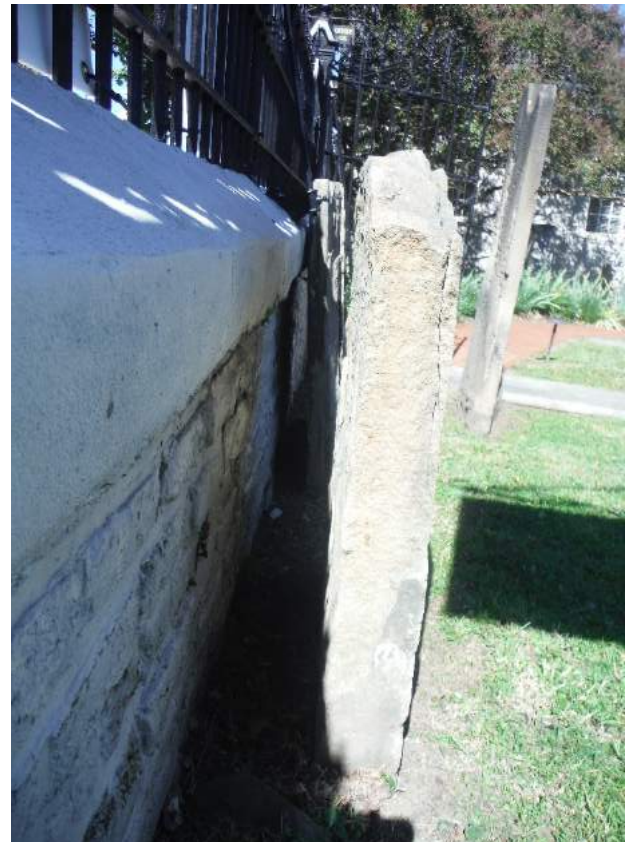
There are obvious chips and dents along with other mineral elements visible within the substrate.

There is a small hairline fracture that is 11 3/4" from the left and 14" from the right running 5 3/4" long.

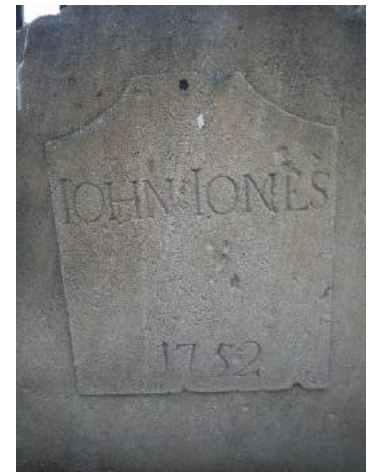
This is pitting on the face.

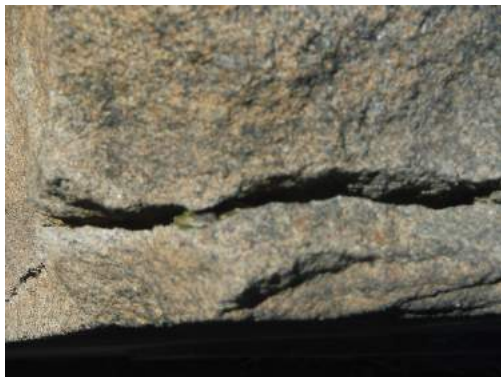
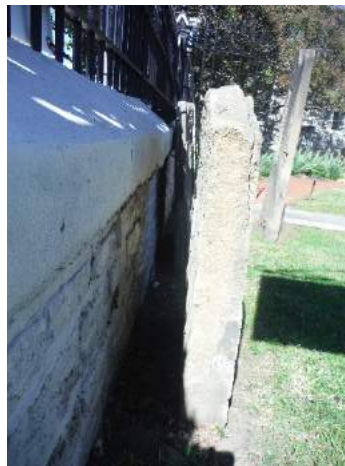
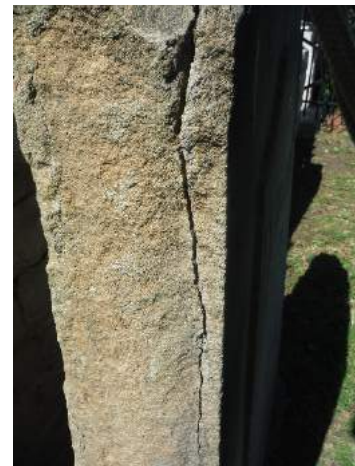
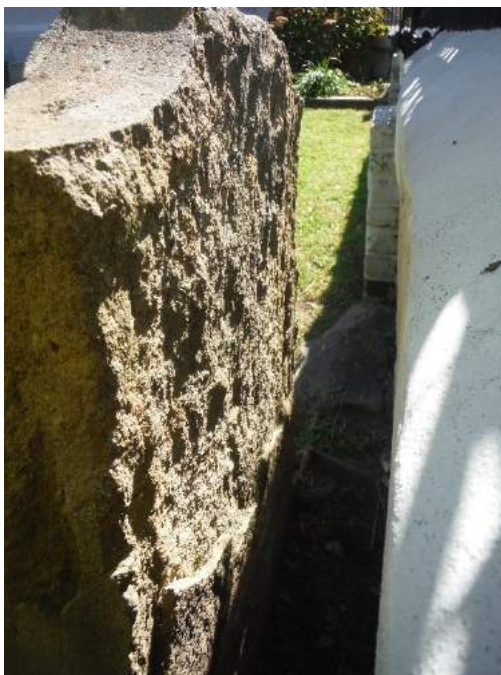
There is approximately 1 inch loss of material along the top. 1 1/8 inch delaminated width at the top and tapers 1/4 at the bottom. The delaminate tapers left to right 17 3/4" ground and 12 inches to the top. It has a 5/8 inch depth of loss, and runs 12 3/4 inch across the top and curves left before it fades into the substrate along the right.

There is a crevice along the top 1/4" at the widest point and 1/16 of an inch at the narrowest.

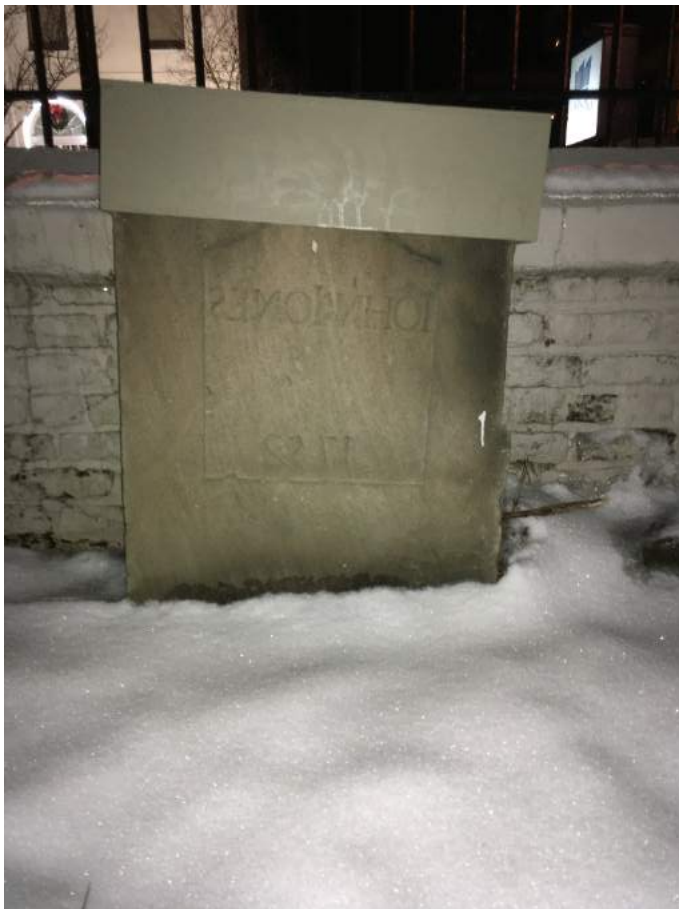
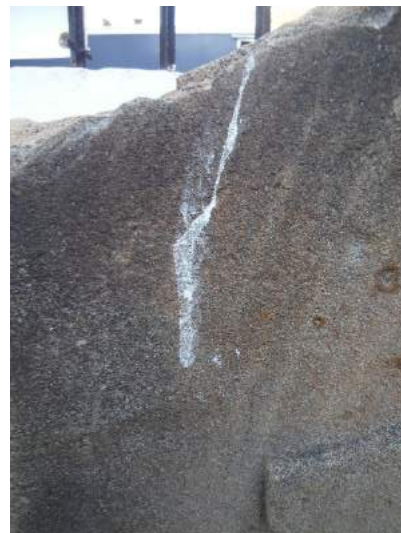
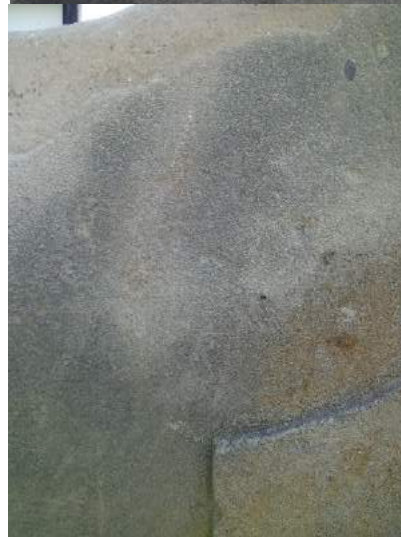
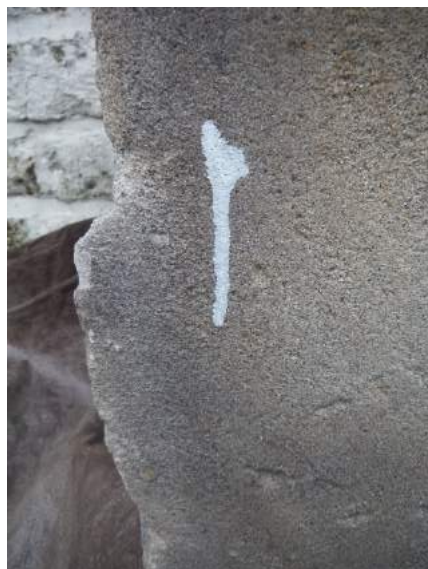
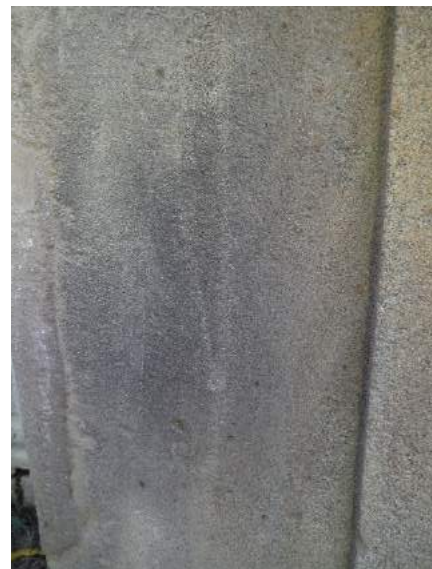
The application of the chemical cleaning solution exposed some white paint that had apparently dripped on the stone from when the wall on which it was leaning was painted.

A highly volatile solvent was precisely applied directly onto the paint and them scrubbed with a tooth brush. This process was repeated several times until the paint was removed.

With the aide of picks and chisels and other various hand tools, any and all soft and friable substrate material was manually removed. 90 psi of compressed air was then used to blow out loosened debris and any other loose matter from within the crevasses and cracks of the stone.

The stone was then thoroughly rinsed one last time prior to application of mortar.

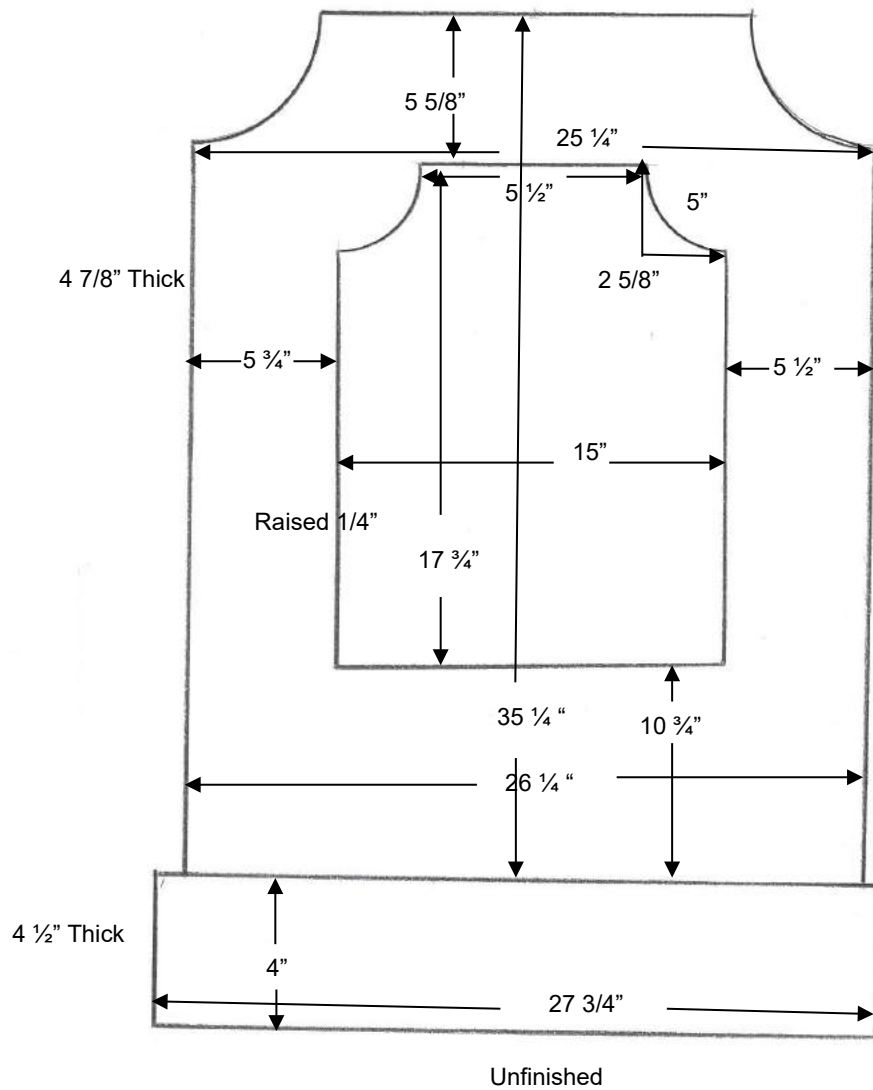
The tablet had one unusual feature which involved the letter 'N', which appeared to have a faint 'X' engraved into it which appears to have had something to do with the alignment of that particular letter.

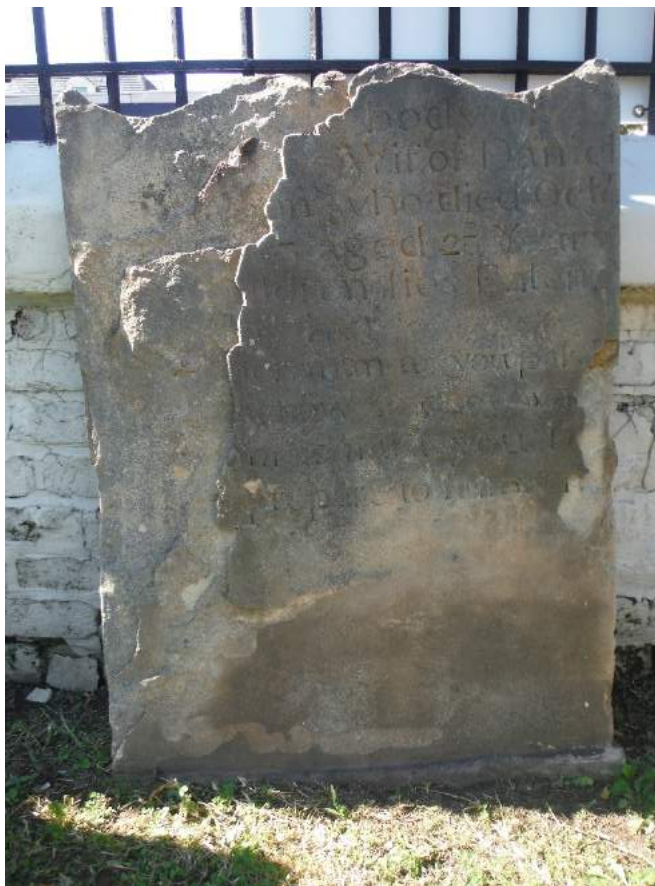
Gravestone #2

Condition: The stone presents with approximately 25% of the face on the left side. Field of loss measures 14 3/4" long at the top of the face to the very edge of the bottom along the top and 35 1/2" high from the bottom to the left shoulder.

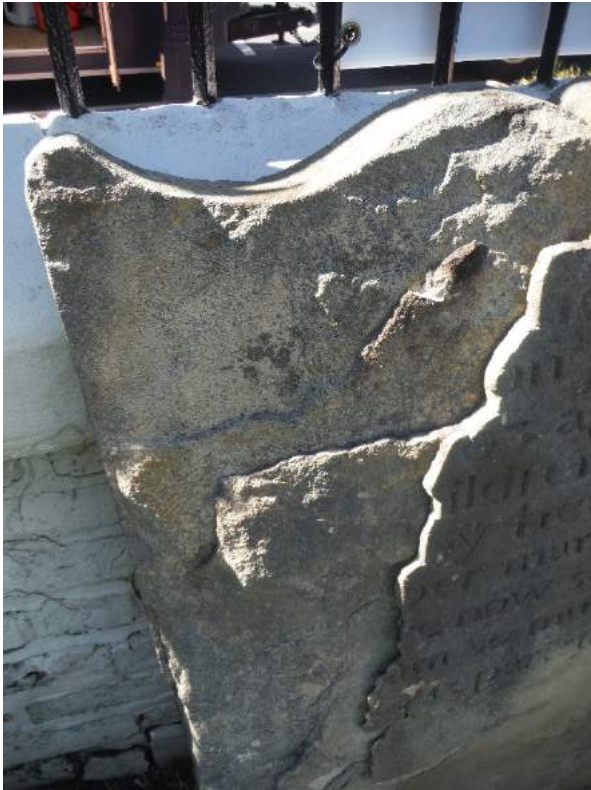
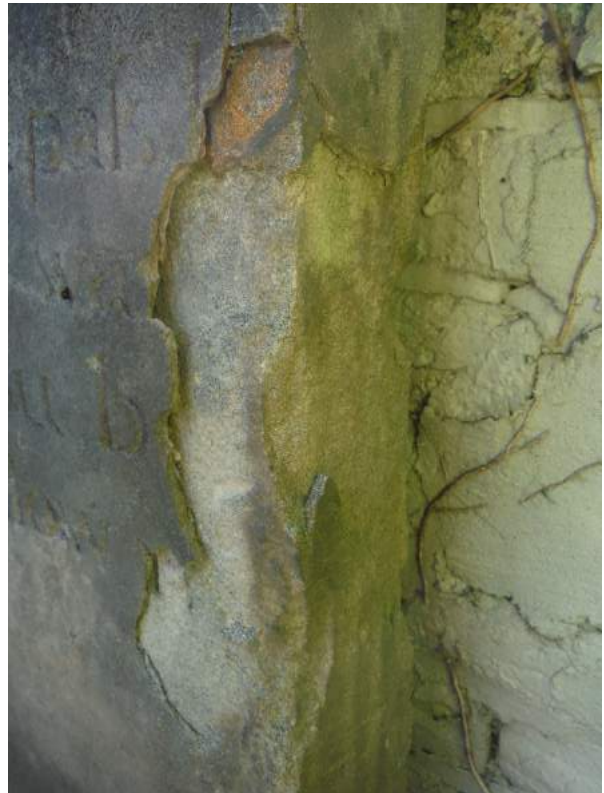
The tablet was found to be leaning backward 5° with a 4" distance from the wall at the bottom left side and 4 1/16" at the right side. The top right side is actually touching the wall which flares out 2 3/4" due to missing material.

There is a 'chip' on the right side of the tablet approximately 3 3/4" wide, 5" long 1 13/16" deep.
