Conservation Preservation Treatment Report

Fredericksburg, Virginia

**St. Georges Episcopal Church
905 Princess Ann Street
Fredericksburg, Virginia 22401**

January 2021

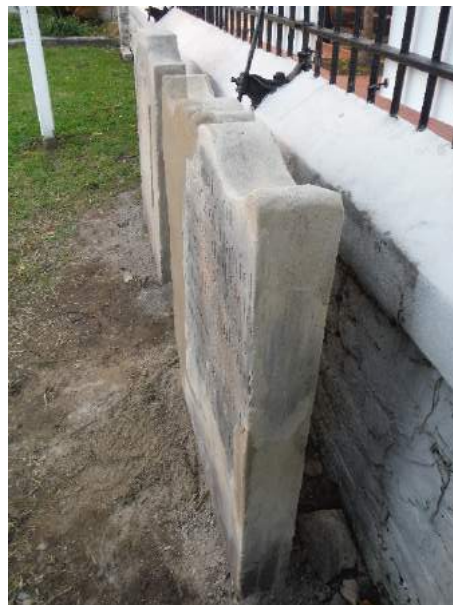
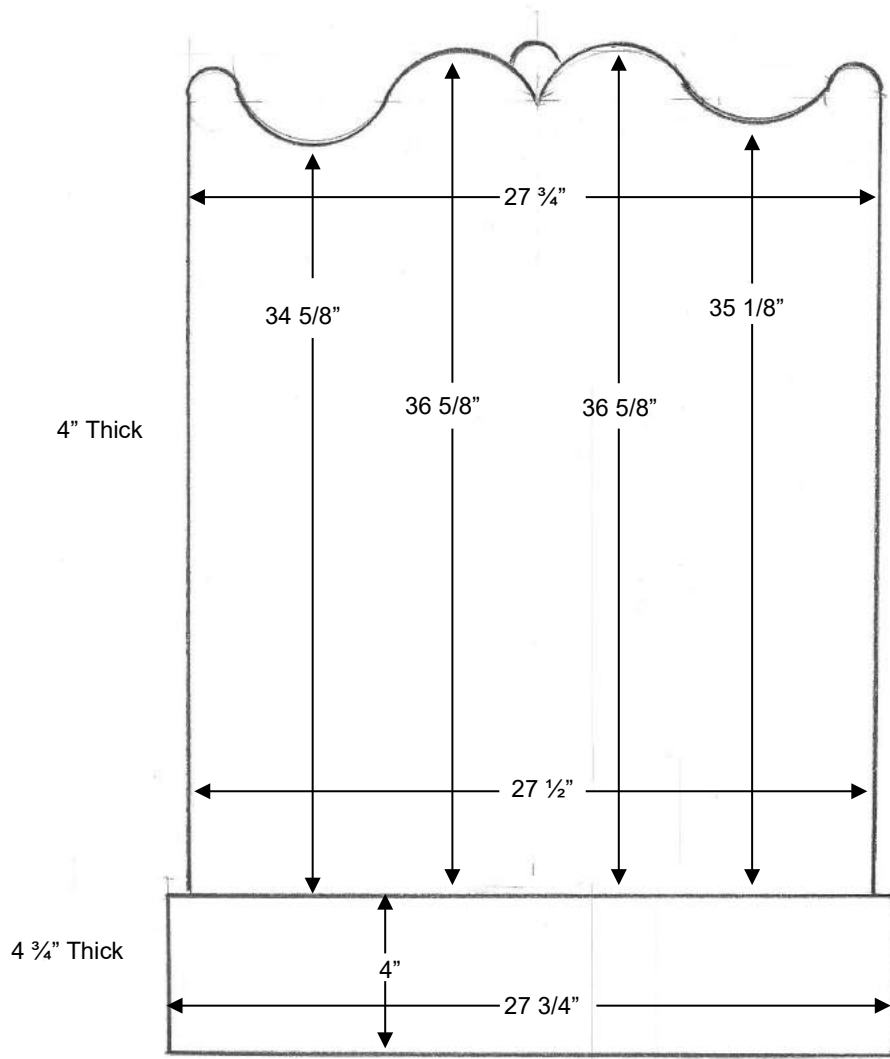
Effort was made to 're-engage' the missing portions of the inscription, however; the weather forecast was no conducive for such an effort.

A stencil will be made and effort to engrave the missing portions of the inscription will be attempted in the Spring.
